Technical Memorandum #1

Before and After Evaluation of the "Pre-Signal" Control at the Prince Road/I-10 UPRR Railroad Crossing

Pima Association of Governments
And Member Agencies

DMJM HARRIS | AECOM

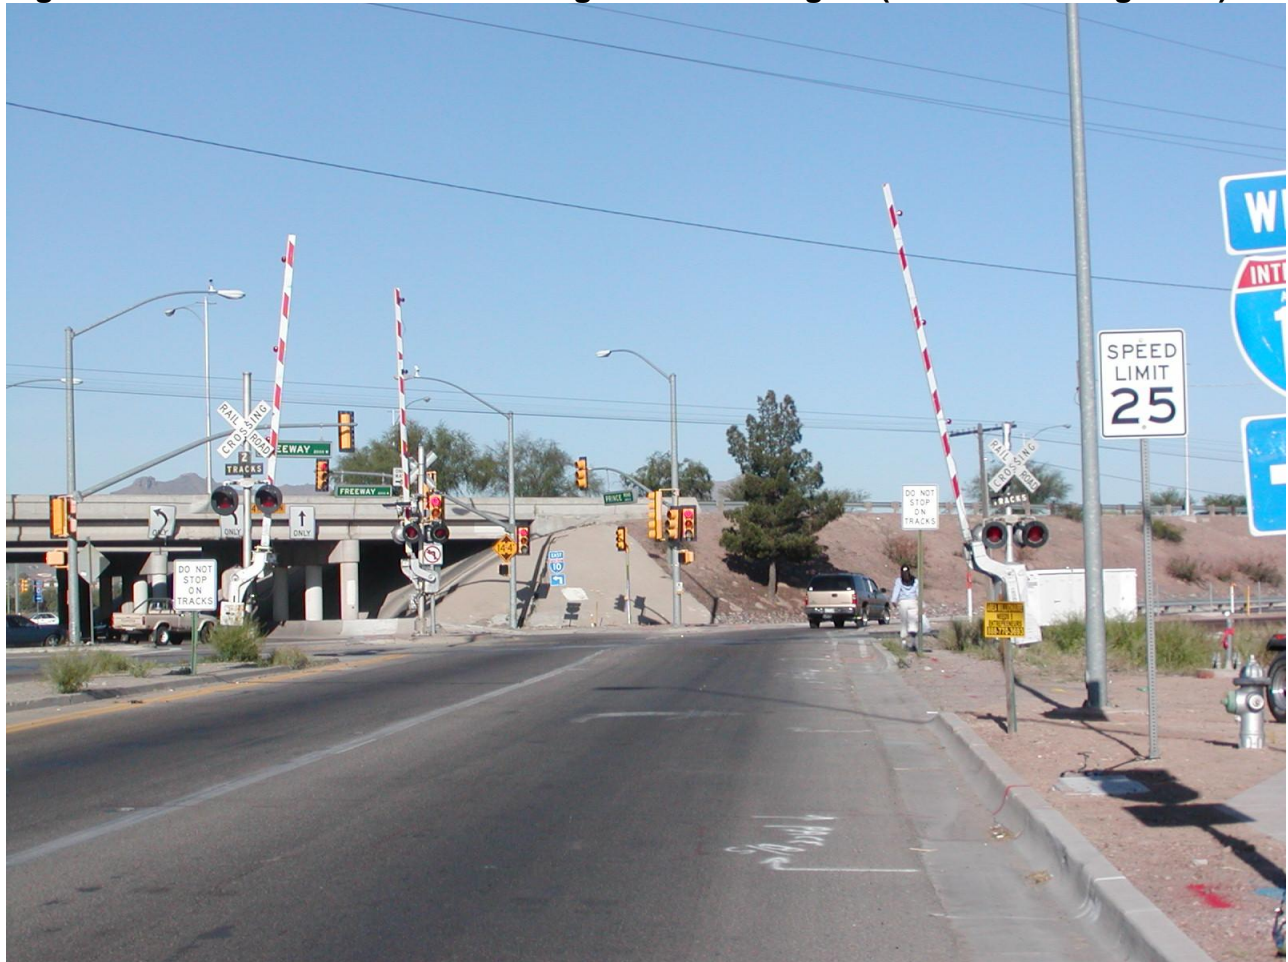
Figure 3: Prince Road/UPRR Crossing Before Pre-Signal (4-13-04 Looking West)

Gates on each side of the roadway are provided on the upstream side of the tracks in each direction. The median sufficiently deters vehicles from driving around the gates. White stop bars were provided in advance of the tracks, as well as the standard railroad crossing pavement markings. The pavement markings and signing at the Prince Road/UPRR crossing are shown in Figure 2. Due to the heavy traffic volumes on Prince Road and the breaking of vehicles on the approach to the tracks, the railroad crossing pavement markings wear out rapidly. This is evident in the photograph in Figure 3.

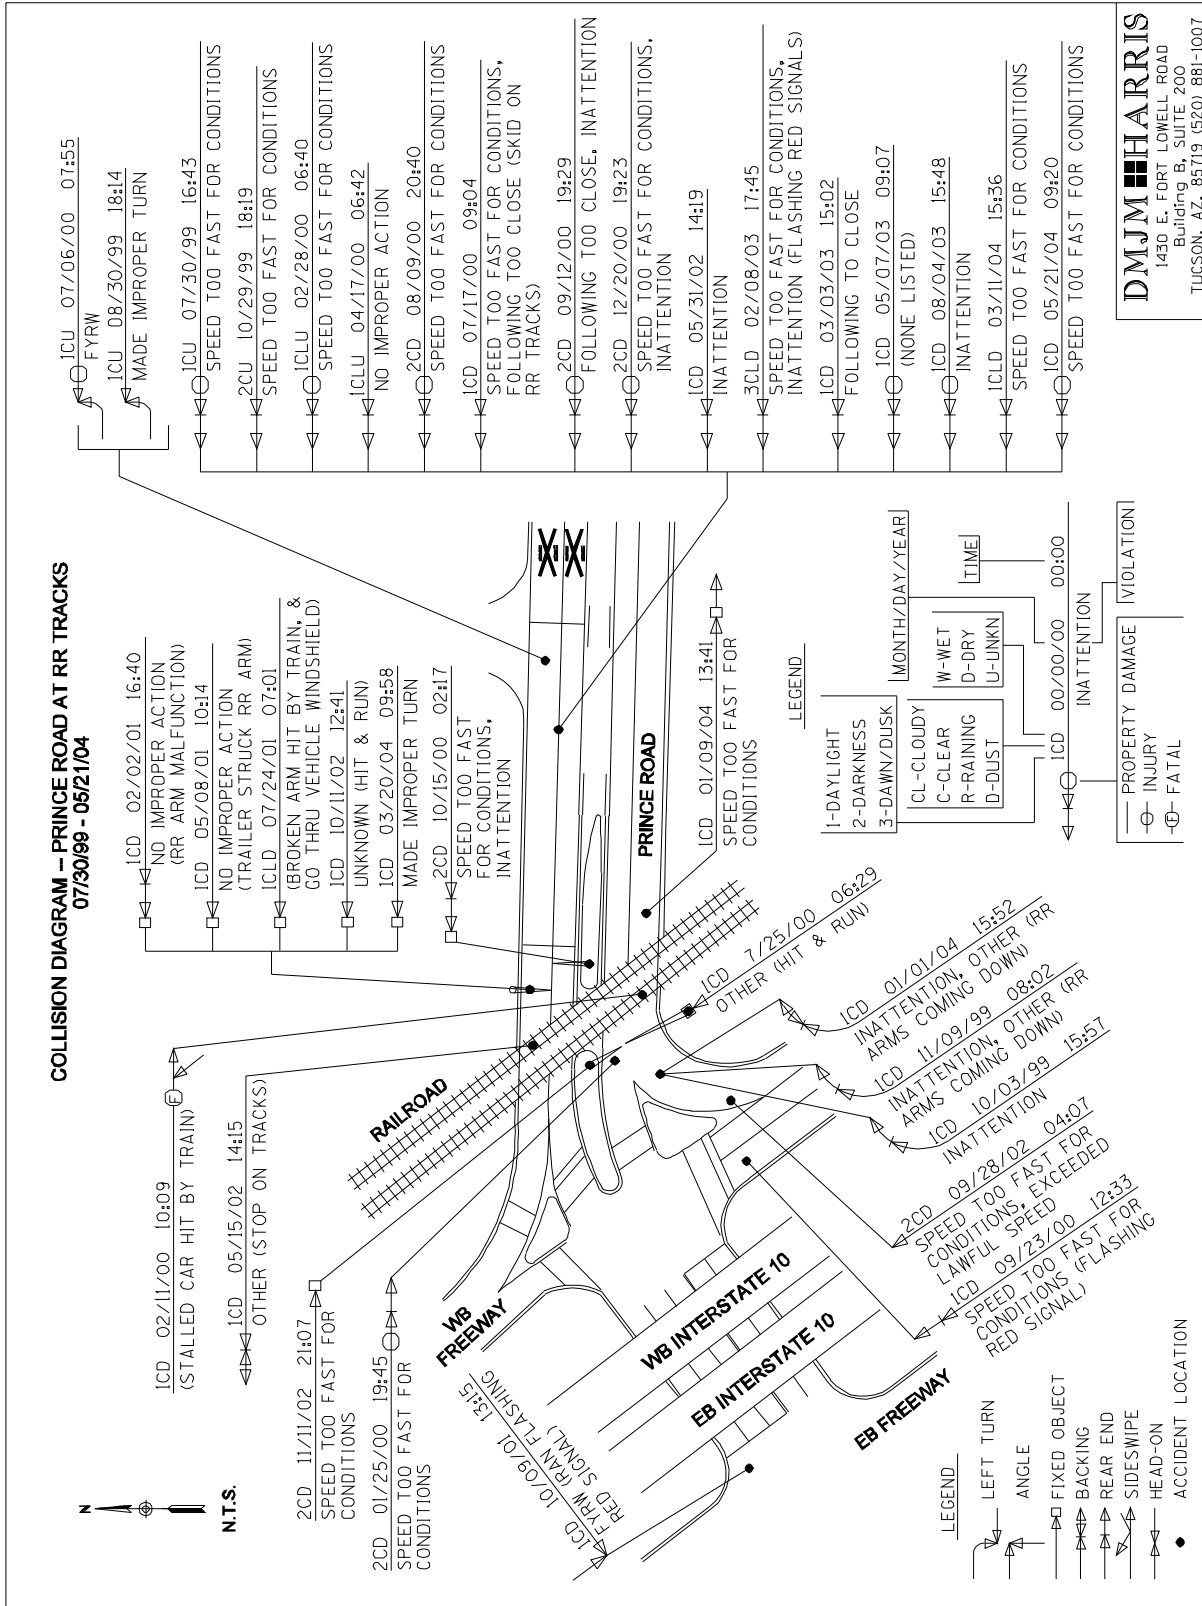
Figure 5: Collision Diagram

Of the 254 total accidents, 35 were noted as being related to the railroad crossing in the police reports. These accidents include vehicles hitting the railroad traffic control equipment, vehicles running into the gates, vehicles taking evasive action due to the gates, rear-end collisions that occurred when the gates were down, and one vehicle that was hit by a train. The railroad related accidents are summarized in Table 2 and illustrated in the collision diagram in Figure 5. A more detailed Accident Summary Table is provided in Appendix B.

As indicated in Table 2, the predominant type of railroad related accident was the rear-end collision, of which there were 18. Of the 18 rear-end collisions, 15 occurred on the westbound approach to the railroad tracks when either the flasher was activated, the gates were coming down or a train was passing through. As illustrated in Figure 5, most of the injury accidents (8 of 10) were westbound rear-end collisions approaching the tracks. Of the other three rear-end collisions, one was in the eastbound direction involving a vehicle that was proceeding too fast for conditions and resulted in an injury. The other two rear-end accidents involved northbound vehicles from the frontage road hitting vehicles waiting to turn east that were stopped due to an on-coming train.

The second most common type of accident that was reported was vehicles hitting the railroad gates, of which there were 8 occurrences. Some of these accidents occurred while the gates were coming down. In one case, the gates malfunctioned and a vehicle hit them. When the officer arrived on the scene, the gates were still malfunctioning, as was noted in the police report.
